**MBK Partnership/
North Ridge Estates Subdivision
Responsible Party Removal Action Report
Klamath Falls, Oregon
TDD: 03-07-0011**

Contract: 68-S0-01-01
February 2005

**MBK PARTNERSHIP/ NORTH RIDGE ESTATES SUBDIVISION RESPONSIBLE PARTY
REMOVAL ACTION REPORT
TDD: 03-07-0011**

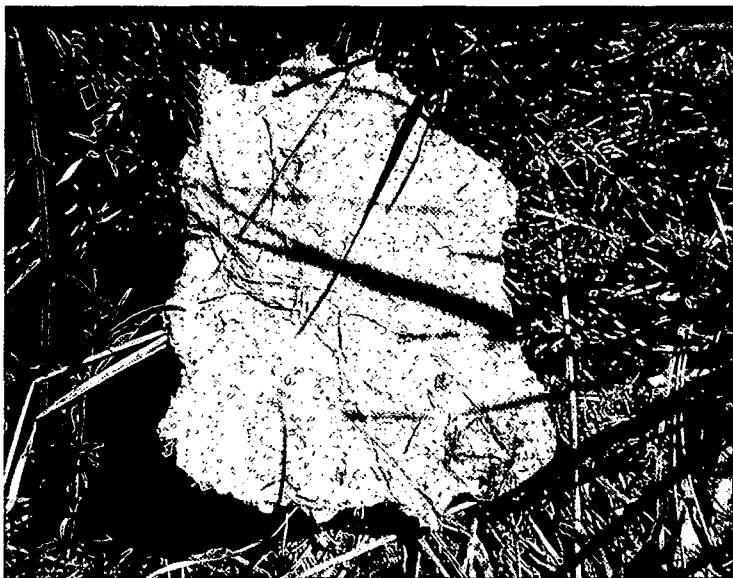
Photo 9 Roofing paper impregnated with asbestos observed on the ground at the MBK/NRE site.
Direction: Down

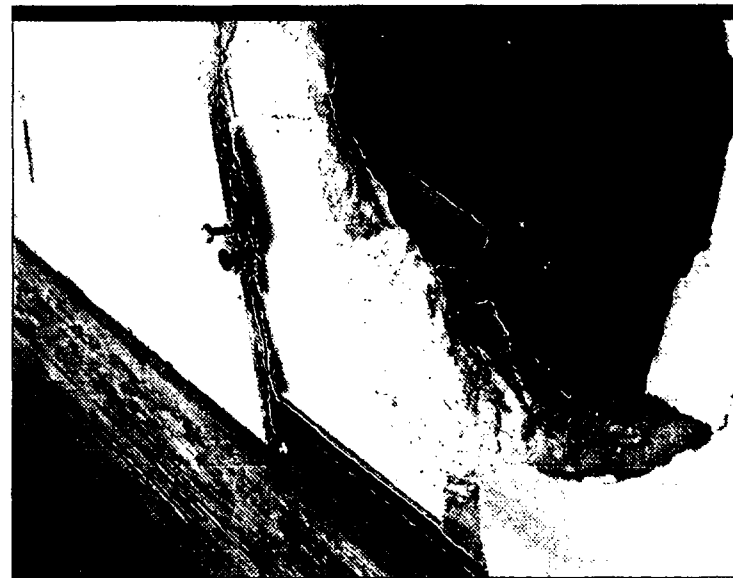
Photo 10 A view of the warehouse siding. Note that it contains CAB.
Direction: North

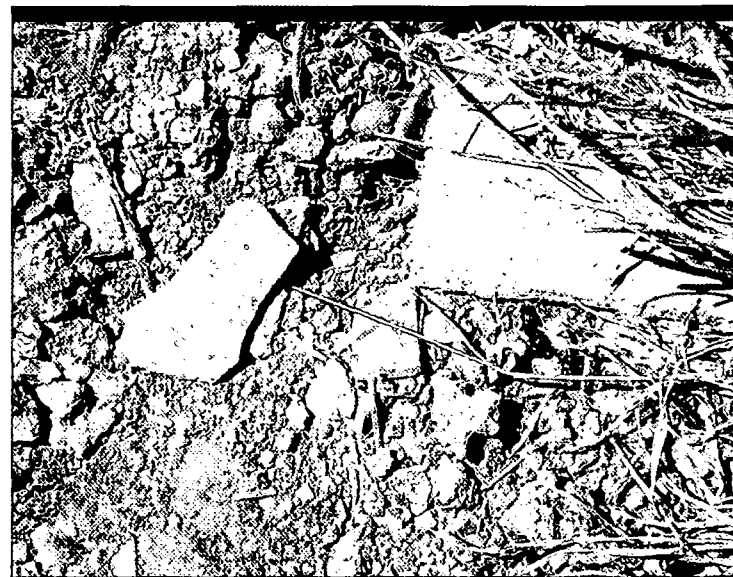
Photo 12 Red, asbestos-containing, floor tile and CAB observed in site soil.
Direction: Down

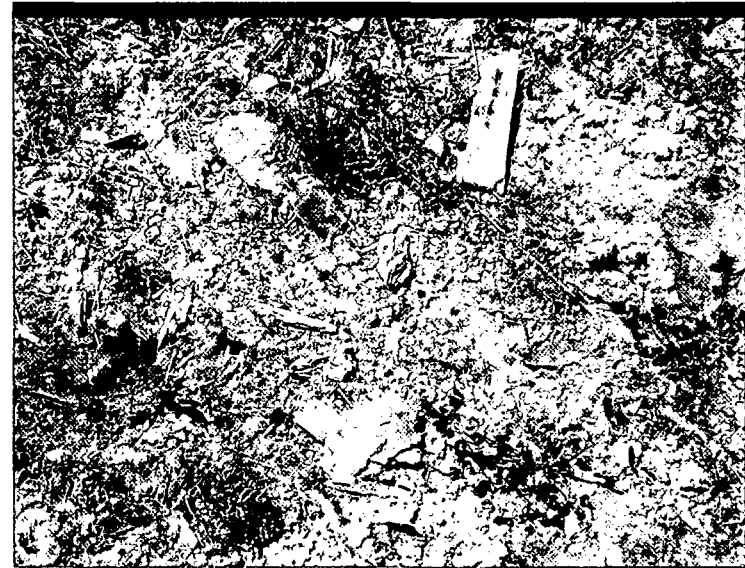
Photo 14 Roofing material later removed from resident's property.
Direction: Southeast

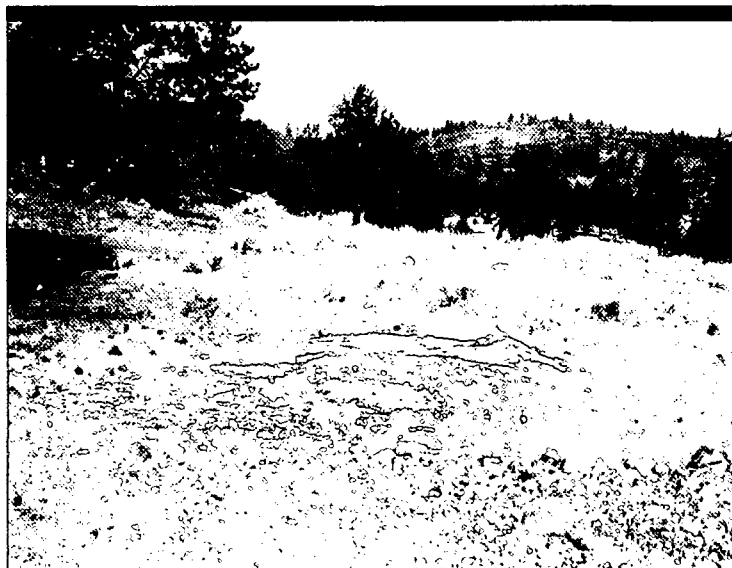
Photo 37 Lead-contaminated soils at the MBK-C property.
Direction: Northwest

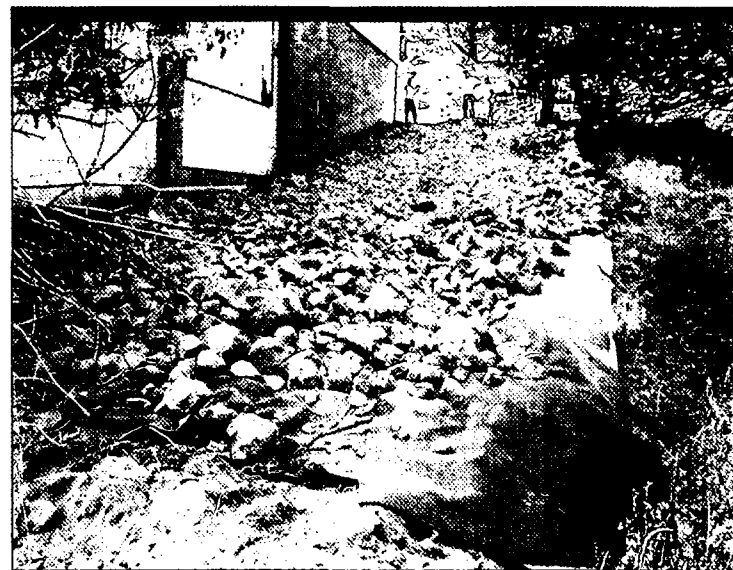
Photo 48 Plastic, soil, and rock cover over erosion prone area north of warehouse.
Direction: West

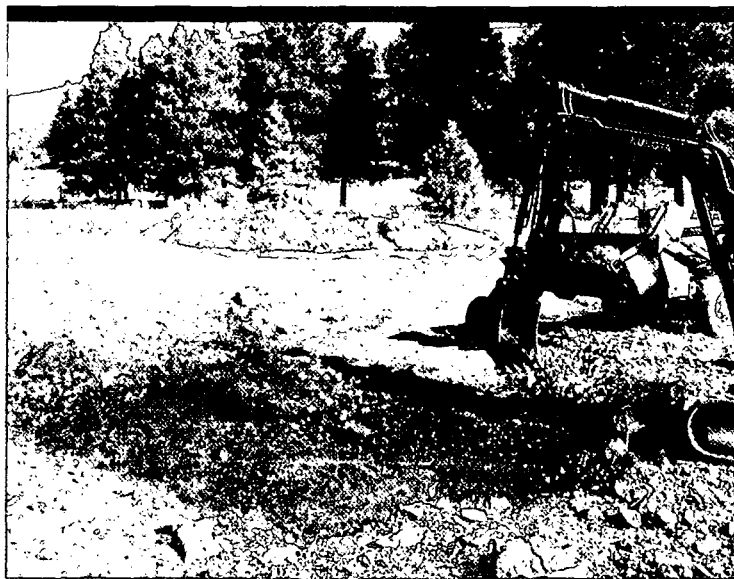
Photo 49 Excavating lead-contaminated soil on MBK-C property.
Direction: North

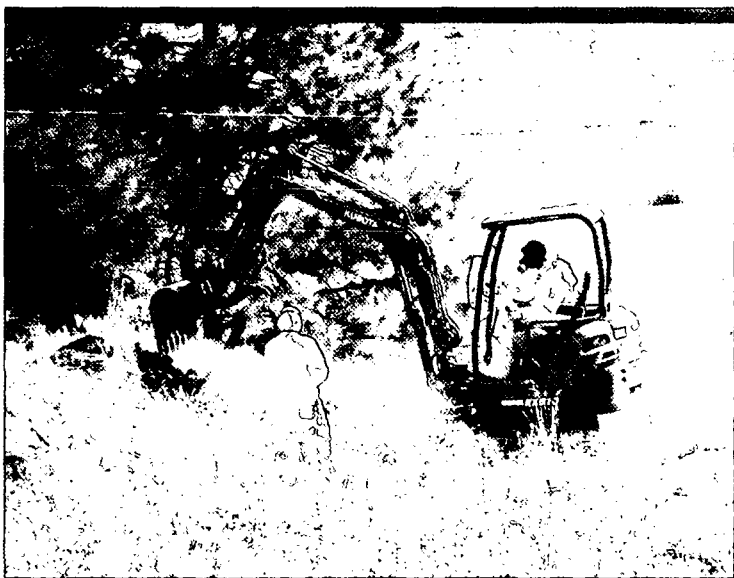
Photo 51 Removing exposed asbestos-covered piping.
Direction: East

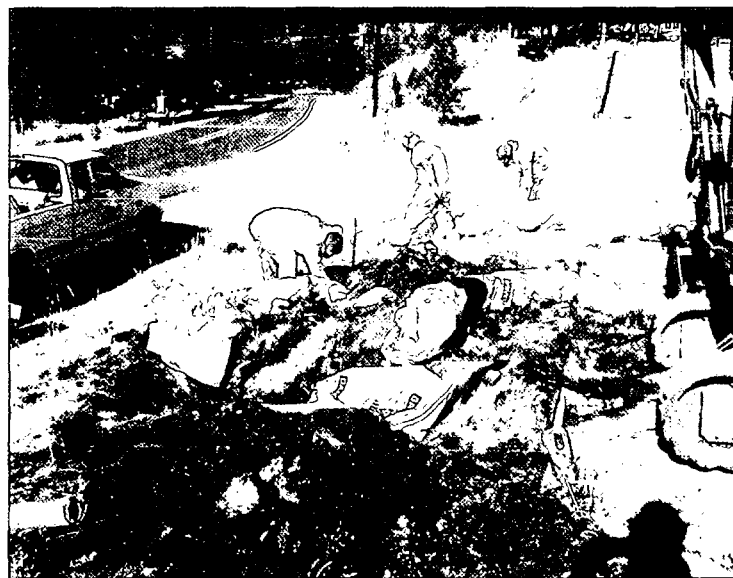
Photo 52 Wrapping exposed asbestos-insulated steam pipe.
Direction: Northwest
